Visual Inspection Report

300 Park Street
Edwardsville, IL 62025 (Edwardsville)

Prepared for: Edwardsville Township

Prepared by: Town and Country Inspections, Inc.
13 Sugar Lane
Collinsville, IL 62234
Commercial Building Report of Conditions

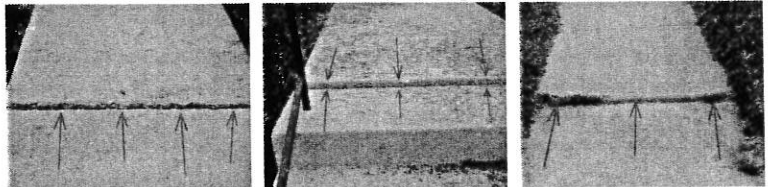
- A NP NI M D SH
1. **Parking Lot Asphalt :** The parking lot is not properly striped with the appropriate handicapped accessible notations for the lot and entryways. It was undetermined at the time of inspection as to the proper water evacuation of the lot as to prevent ponding of water that would contribute to ice blocking hazards.
2. **Walks: Concrete :** Trip hazards are noted at the public walks along Park Street and at the entrance of the building. Uneven concrete pads as well as excessive gaps between pads will potentially cause trip hazards. It is recommended that the offending pads be ground at the displacement points and filled or the pads be removed and re-poured. For the pads that have excessive gaps between them, it is recommended that the gaps be properly filled with mortar or concrete or removed and re-poured.

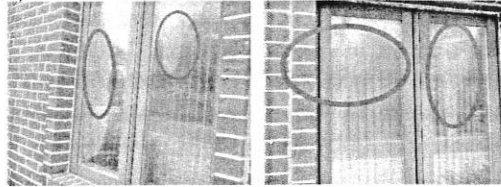
6. Exterior Doors: Metal : The metal exterior door of the basement
7. Windows: Wood Casement : Leaking insulated glass with fogging and/or moisture between glass panes. This occurs on most of the windows. This impairs effective light entrance into the building as well as the thermal properties of the window. Repairs require pane replacements.

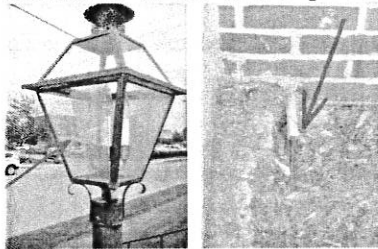
- 8. Window Screens:
- 9. Basement Windows: Steel casement
- 10. Exterior Lighting: Pole light : The glass in the pole light is not secured in the frame and could easily blow out in winds or fall out if the pole is jarred.

Additionally, the electrical service wire to the light is exposed at the base of the bricks at the front of the building near the front porch. The wire must be secured in conduit with wire protection at the service point.

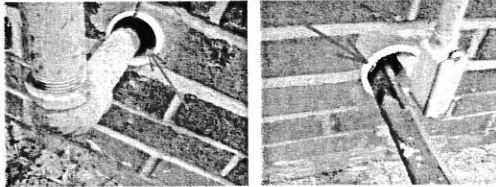
4. Service Entry Thru-wall Conduit : The service entry points should be sealed with putty to prevent unnecessary exterior air entry to the basement. This aids in increasing heating and cooling efficiency.

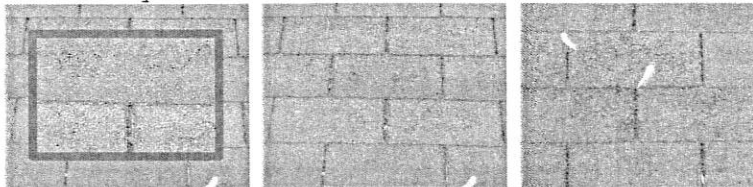
2. **Material:** Asphalt-Fiberglas, Standard 3-Tab shingle : Roof shows signs of normal deterioration. However, periodic examination would help to detect serious deterioration. This roof has an estimated 5-7 more years before replacement is necessary.

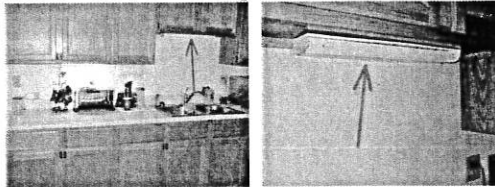
1. Air Gap Present? Yes No No air gap.
2. Sink: Stainless Steel
3. Electrical: 110 VAC : Countertop outlets are not protected with Ground Fault Interrupters. Suggest qualified electrician evaluate and estimate installation of GFCI outlets.

The fluorescent lamp above the sink must have a bulb with a bulb cover to prevent potential electrical shock.

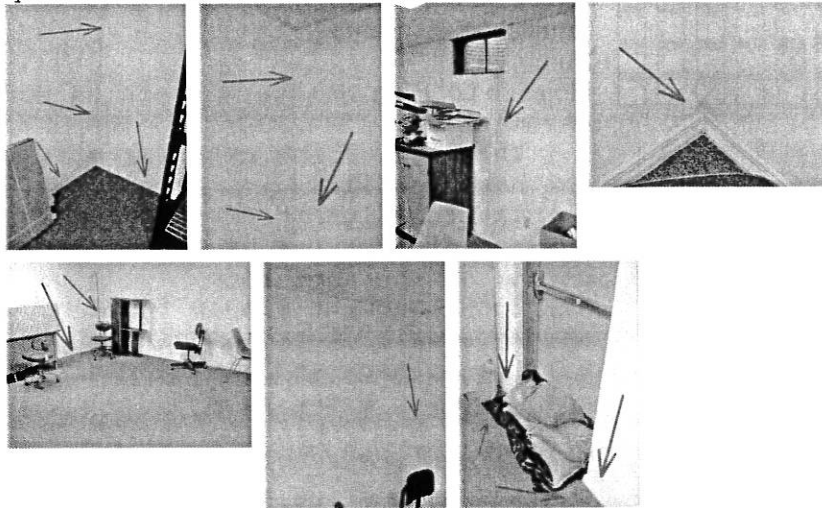
- 2. Ceiling: Suspended Ceiling : Stains noted as a result of ductwork directly above the tiles and because of plumbing leaks.
- 3. Walls: Paint, Drywall : Moisture damage noted on north, west and east walls. Fungal growth noted on wall surfaces at the floor to wall junctions. Moisture stains noted below the basement window frames of 2 of the finished area windows. The stains appear to be the result of an ongoing leak from the base of the window wells and from seepage possibly due to sub-slab water encroachment or from foundation leaks behind finished walls. Total fungal growth encompasses more than 10 square feet for all locations combined. The leaks need to be repaired and finished wall areas remediated properly by a qualified mold remediator.

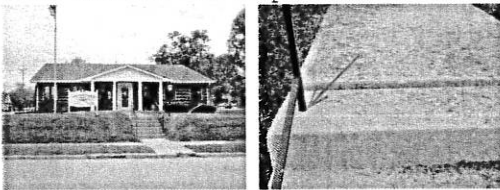
1. **Parking Lot Asphalt :** The parking lot is not properly striped with the appropriate handicapped accessible notations for the lot and entryways. It was undetermined at the time of inspection as to the proper water evacuation of the lot as to prevent ponding of water that would contribute to ice blocking hazards.
2. **Steps/Stoops: Concrete :** The handrail to the front steps is rusted at the base and should be replaced with a more suitable handrail for public use.

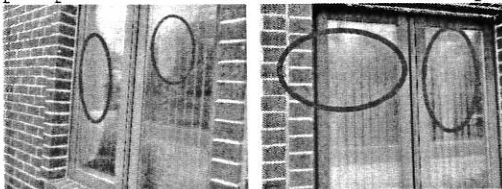
6. **Exterior Doors: Metal :** The metal exterior door of the basement
7. **Windows: Wood Casement :** Leaking insulated glass with fogging and/or moisture between glass panes. This occurs on most of the windows. This impairs effective light entrance into the building as well as the thermal properties of the window. Repairs require pane replacements.

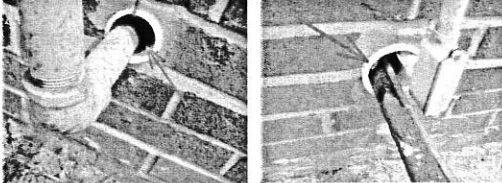
8. Main AC System/Heat Pump Service Entry Thru-wall Conduit : The service entry points should be sealed with putty to prevent unnecessary exterior air entry to the basement. This aids in increasing heating and cooling efficiency.

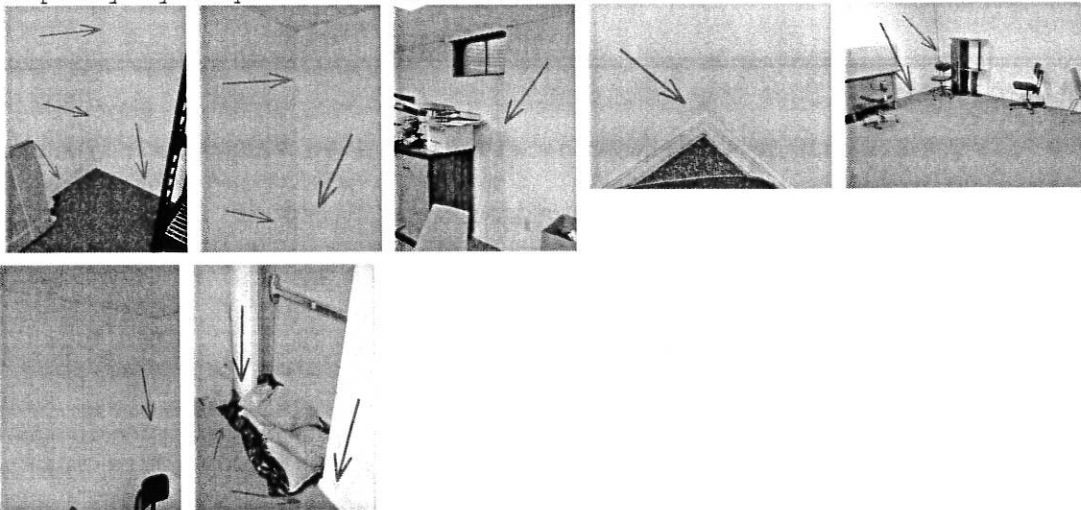
21. Main Basement Ceiling: Suspended Ceiling : Stains noted as a result of ductwork directly above the tiles and because of plumbing leaks.
22. Main Basement Walls: Paint, Drywall : Moisture damage noted on north, west and east walls. Fungal growth noted on wall surfaces at the floor to wall junctions. Moisture stains noted below the basement window frames of 2 of the finished area windows. The stains appear to be the result of an ongoing leak from the base of the window wells and from seepage possibly due to sub-slab water encroachment or from foundation leaks behind finished walls. Total fungal growth encompasses more than 10 square feet for all locations combined. The leaks need to be repaired and finished wall areas remediated properly by a qualified mold remediator.

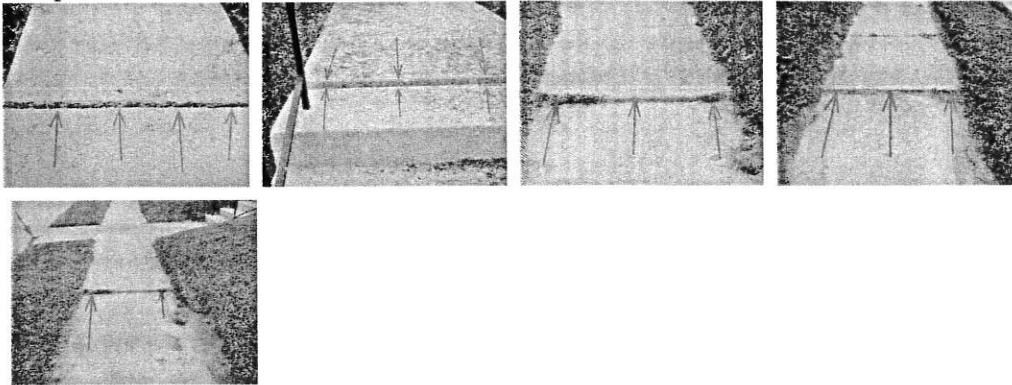
1. **Walks: Concrete :** Trip hazards are noted at the public walks along Park Street and at the entrance of the building. Uneven concrete pads as well as excessive gaps between pads will potentially cause trip hazards. It is recommended that the offending pads be ground at the displacement points and filled or the pads be removed and re-poured. For the pads that have excessive gaps between them, it is recommended that the gaps be properly filled with mortar or concrete or removed and re-poured.

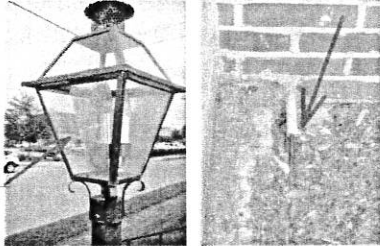
Additionally, the electrical service wire to the light is exposed at the base of the bricks at the front of the building near the front porch. The wire must be secured in conduit with wire protection at the service point.

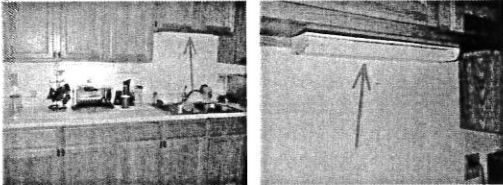
6. 1st Floor, Break Room Kitchen Electrical: 110 VAC : Countertop outlets are not protected with Ground Fault Interrupters. Suggest qualified electrician evaluate and estimate installation of GFCI outlets.

The fluorescent lamp above the sink must have a bulb with a bulb cover to prevent potential electrical shock.
